F-1-199 Jacob Dutrow Farmstead Adamstown Frederick County

Maryland Historical Trust State Historic Sites Inventory MARYLAND INVENTORY OF HISTORIC PROPERTIES Form

Survey	No.	F-1-199
-	-

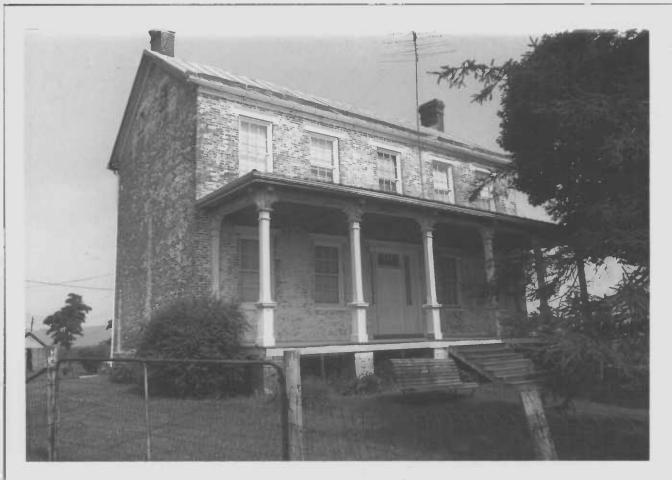
F-1-199 Jacob Dutrow Form stead Frederick County Photo: Janet Davis July 1993 Nea. loc. : Md. SHPO, Crownsville, Md Southeast corner view 1/3

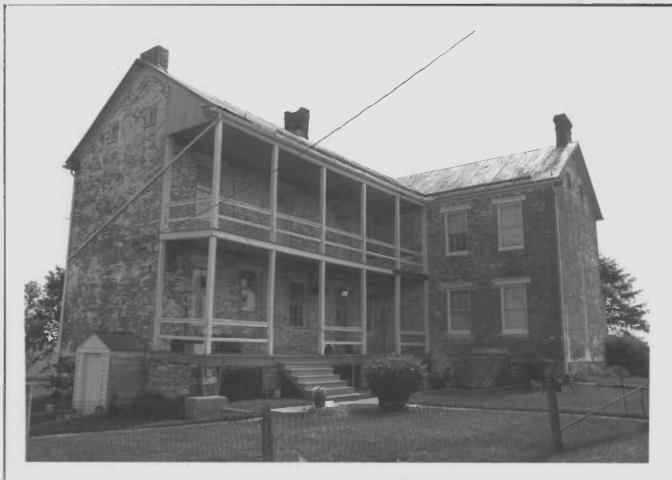
F-1-199 Jacob Dutrow Formstead Frederick County Photo: Janet Davis July 1993 Neg. loc. Md. SHPO, Crownsuite Md Southwest corner view 2/3

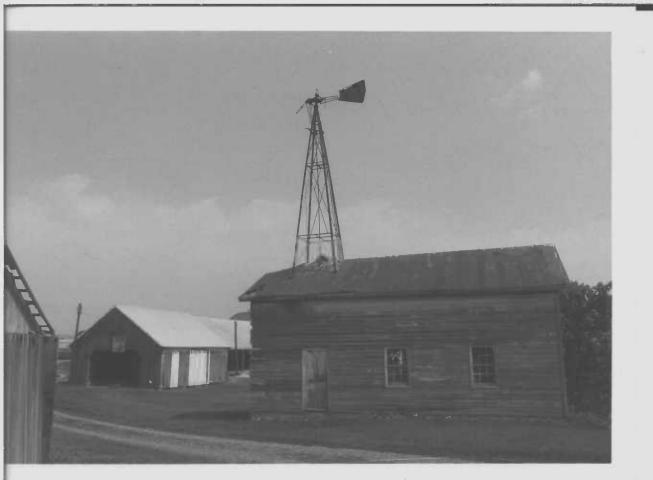
Jacob Dutraw Formstead Frederick County Photo: Jonet Davis July 1993 Neg. loc. And. EHPO, Crownsville, Md. Outbuildings, general view from south
